Appendix F

Structures Inspection Results

FACILITIES CONDITION ASSESSMENT REPORT

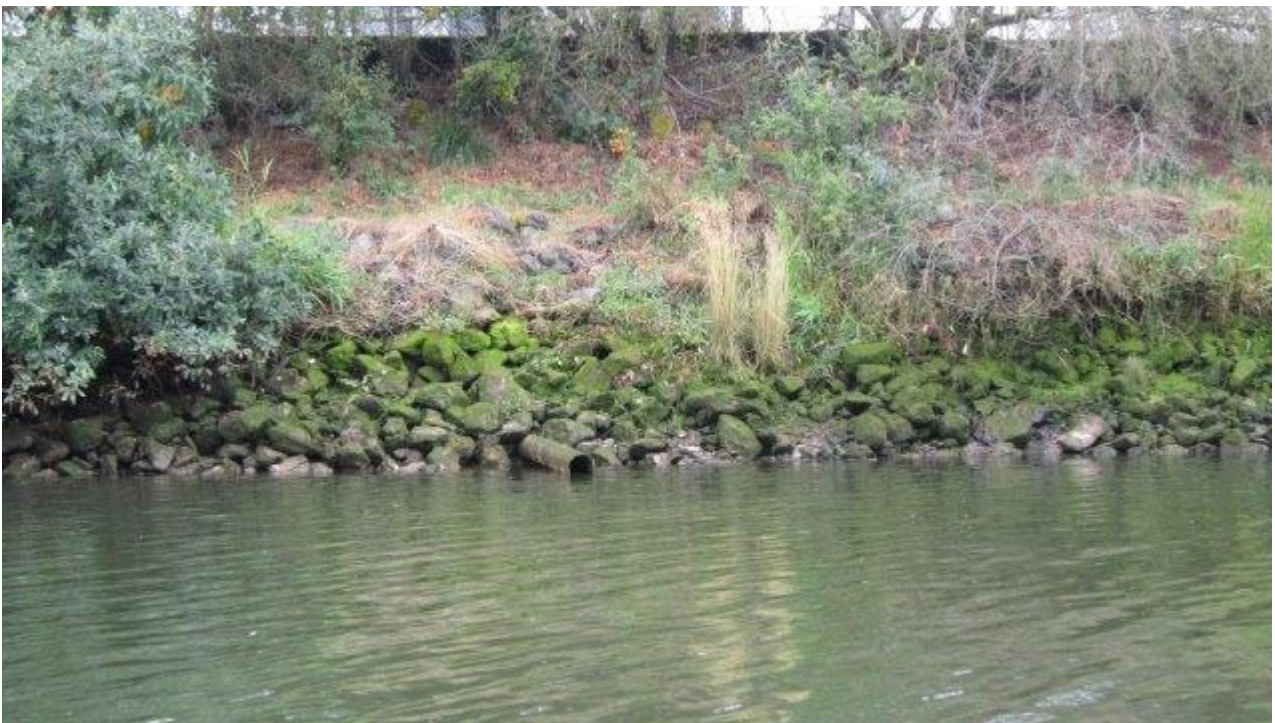
Photo 2098-02: Outfall (Looking West)

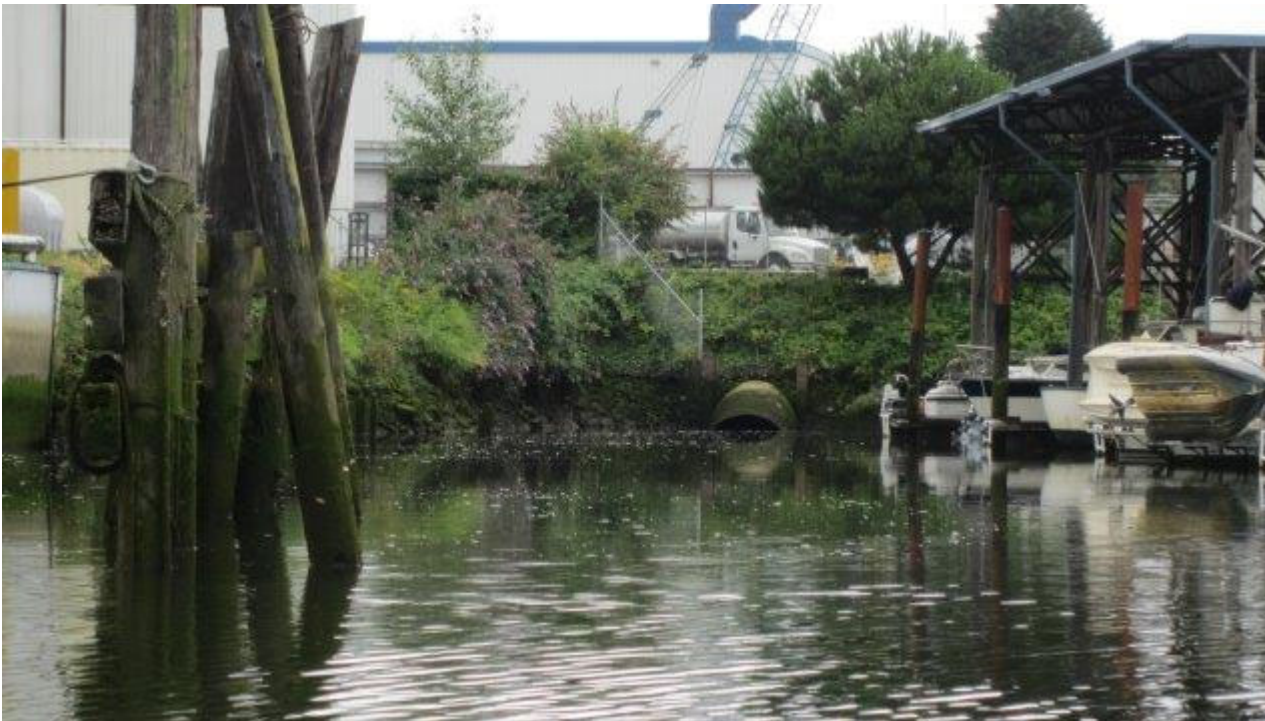
Photo 2100B-01: Outfall at High Tide Level

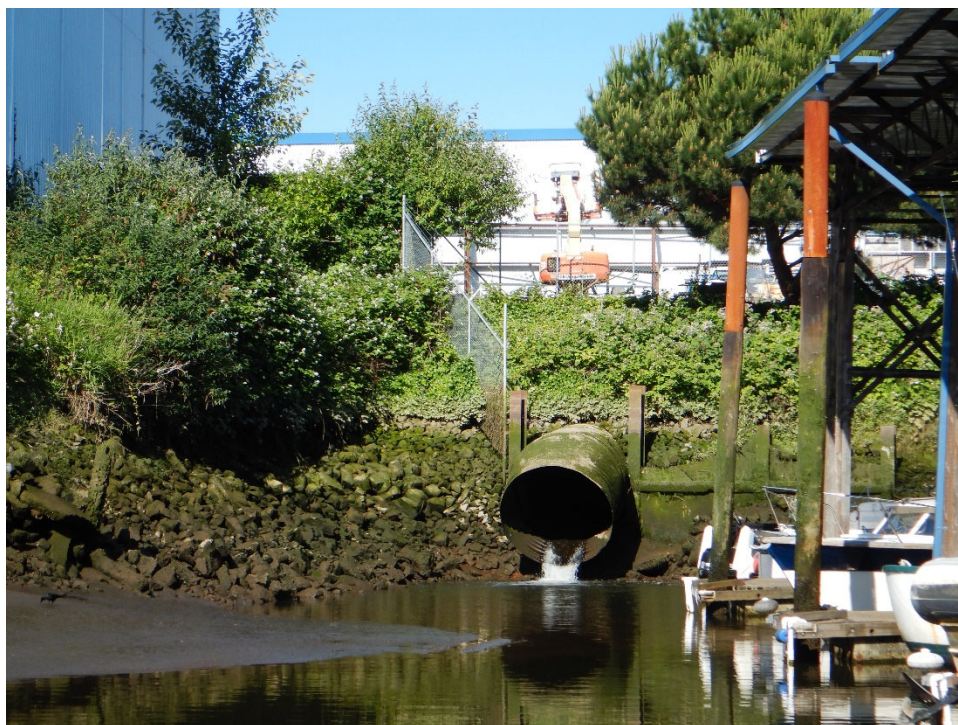
Photo 2100B-02: Outfall at Low Tide Level

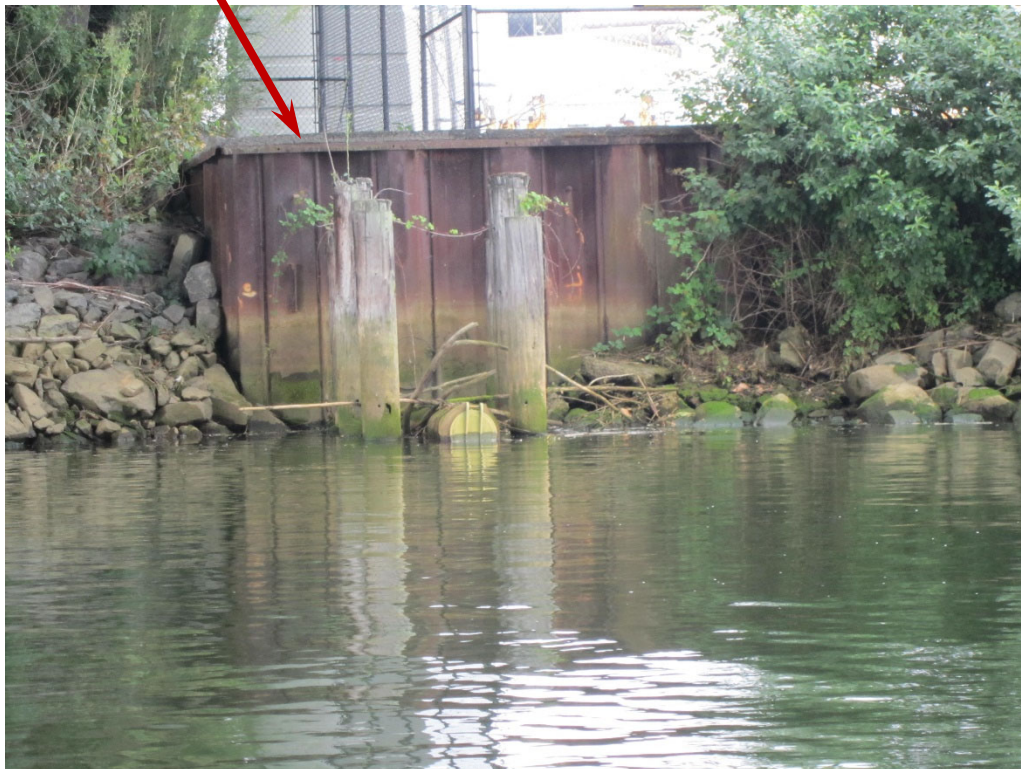
3032-02: Outfall Structure

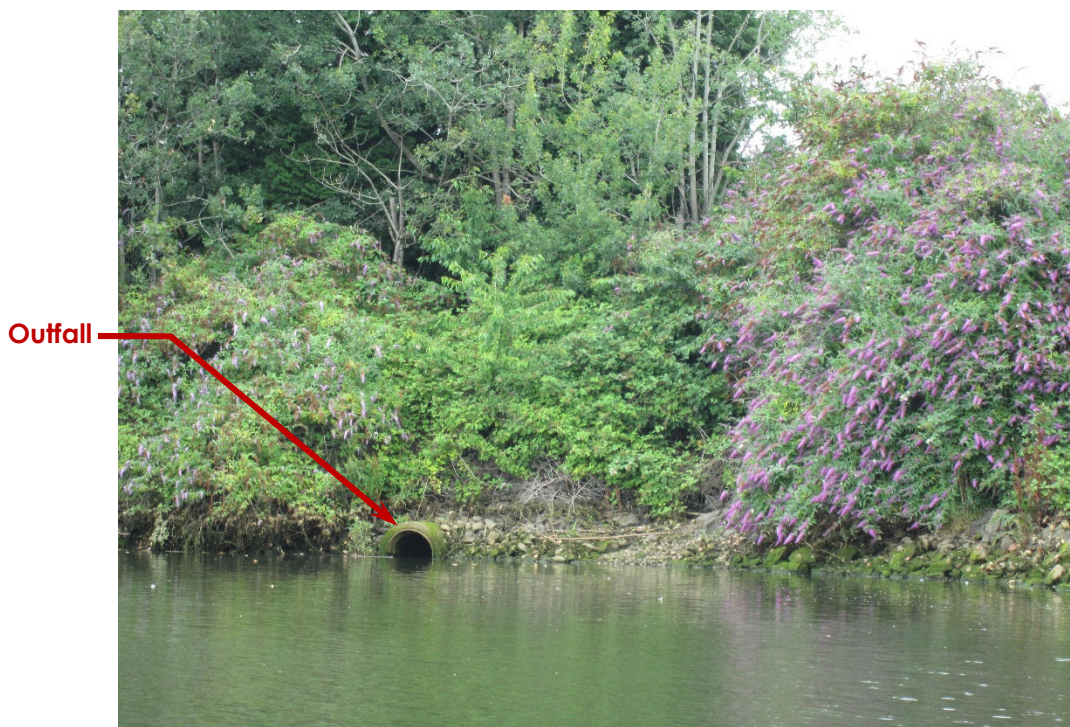
Photo BDC-1-02: Outfall South of Dolphin (Looking East)

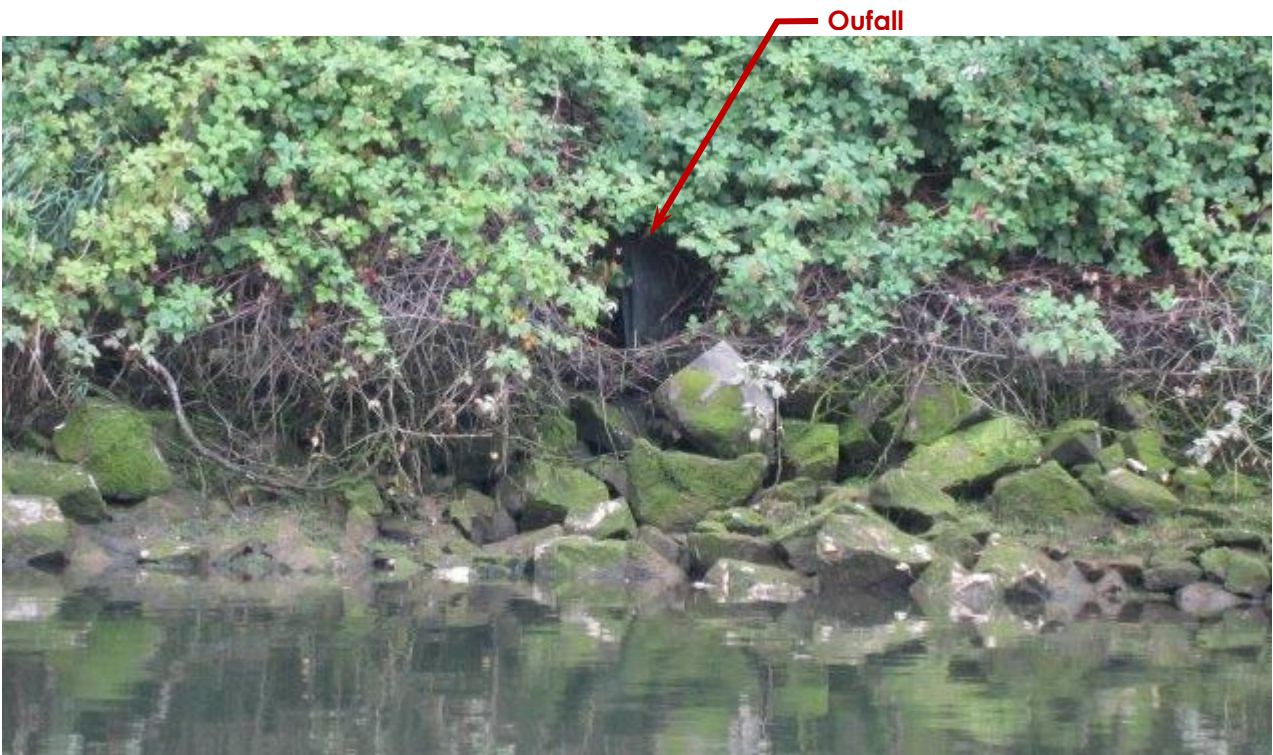
Photo Ditch #2-01: Outfall (Looking West)

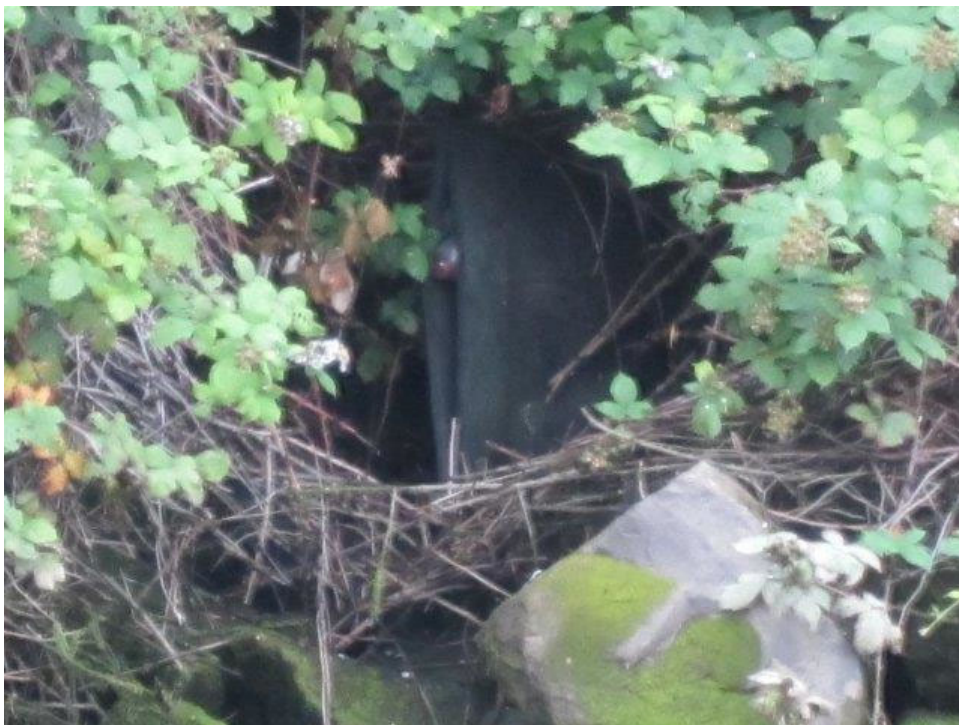
Photo Ditch #2-02: Enlarged Outfall Valve

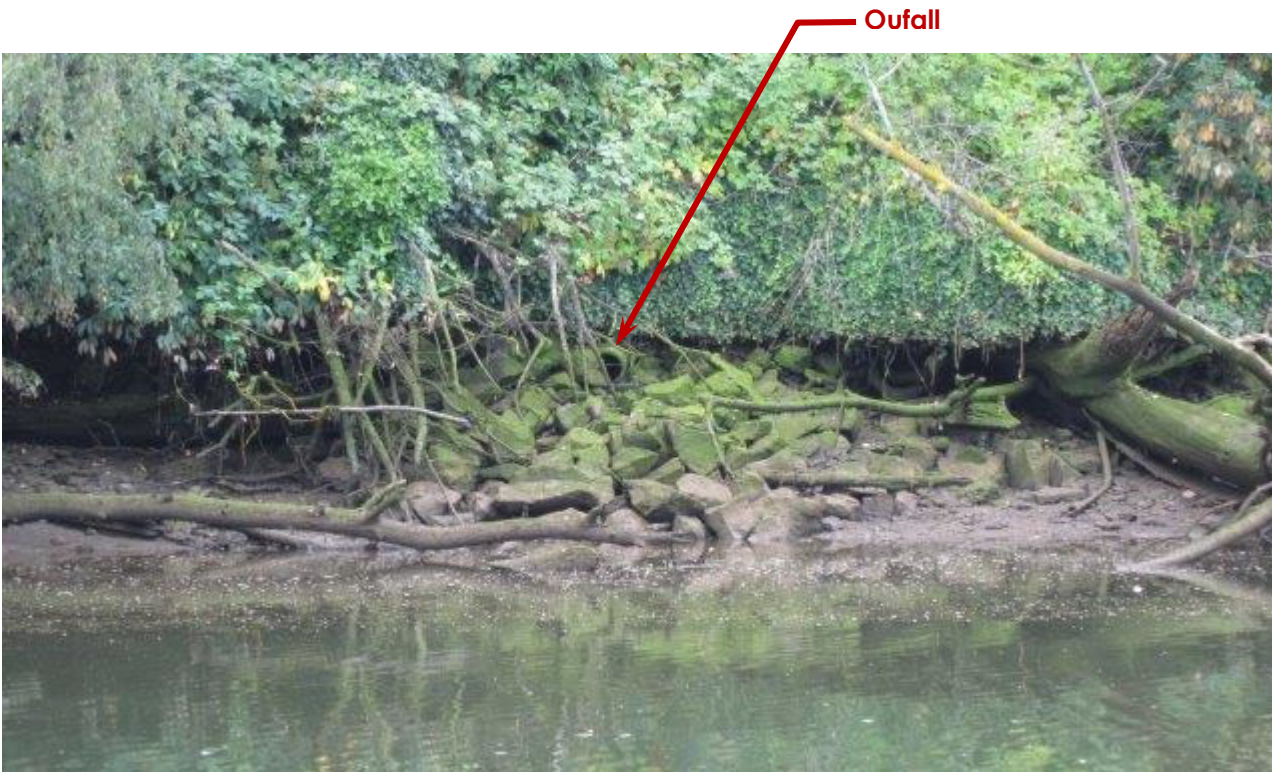
Photo SP3-01: Outfall (Looking West)
